# Surface Water Drainage Narrative/Report

## Layton Crossing (Lots 1 and 2) City of Shoreline, WA (Individual Building Permit)

For Single Family Residential Building Permits at

## Layton Crossing (Lots 1 and 2)

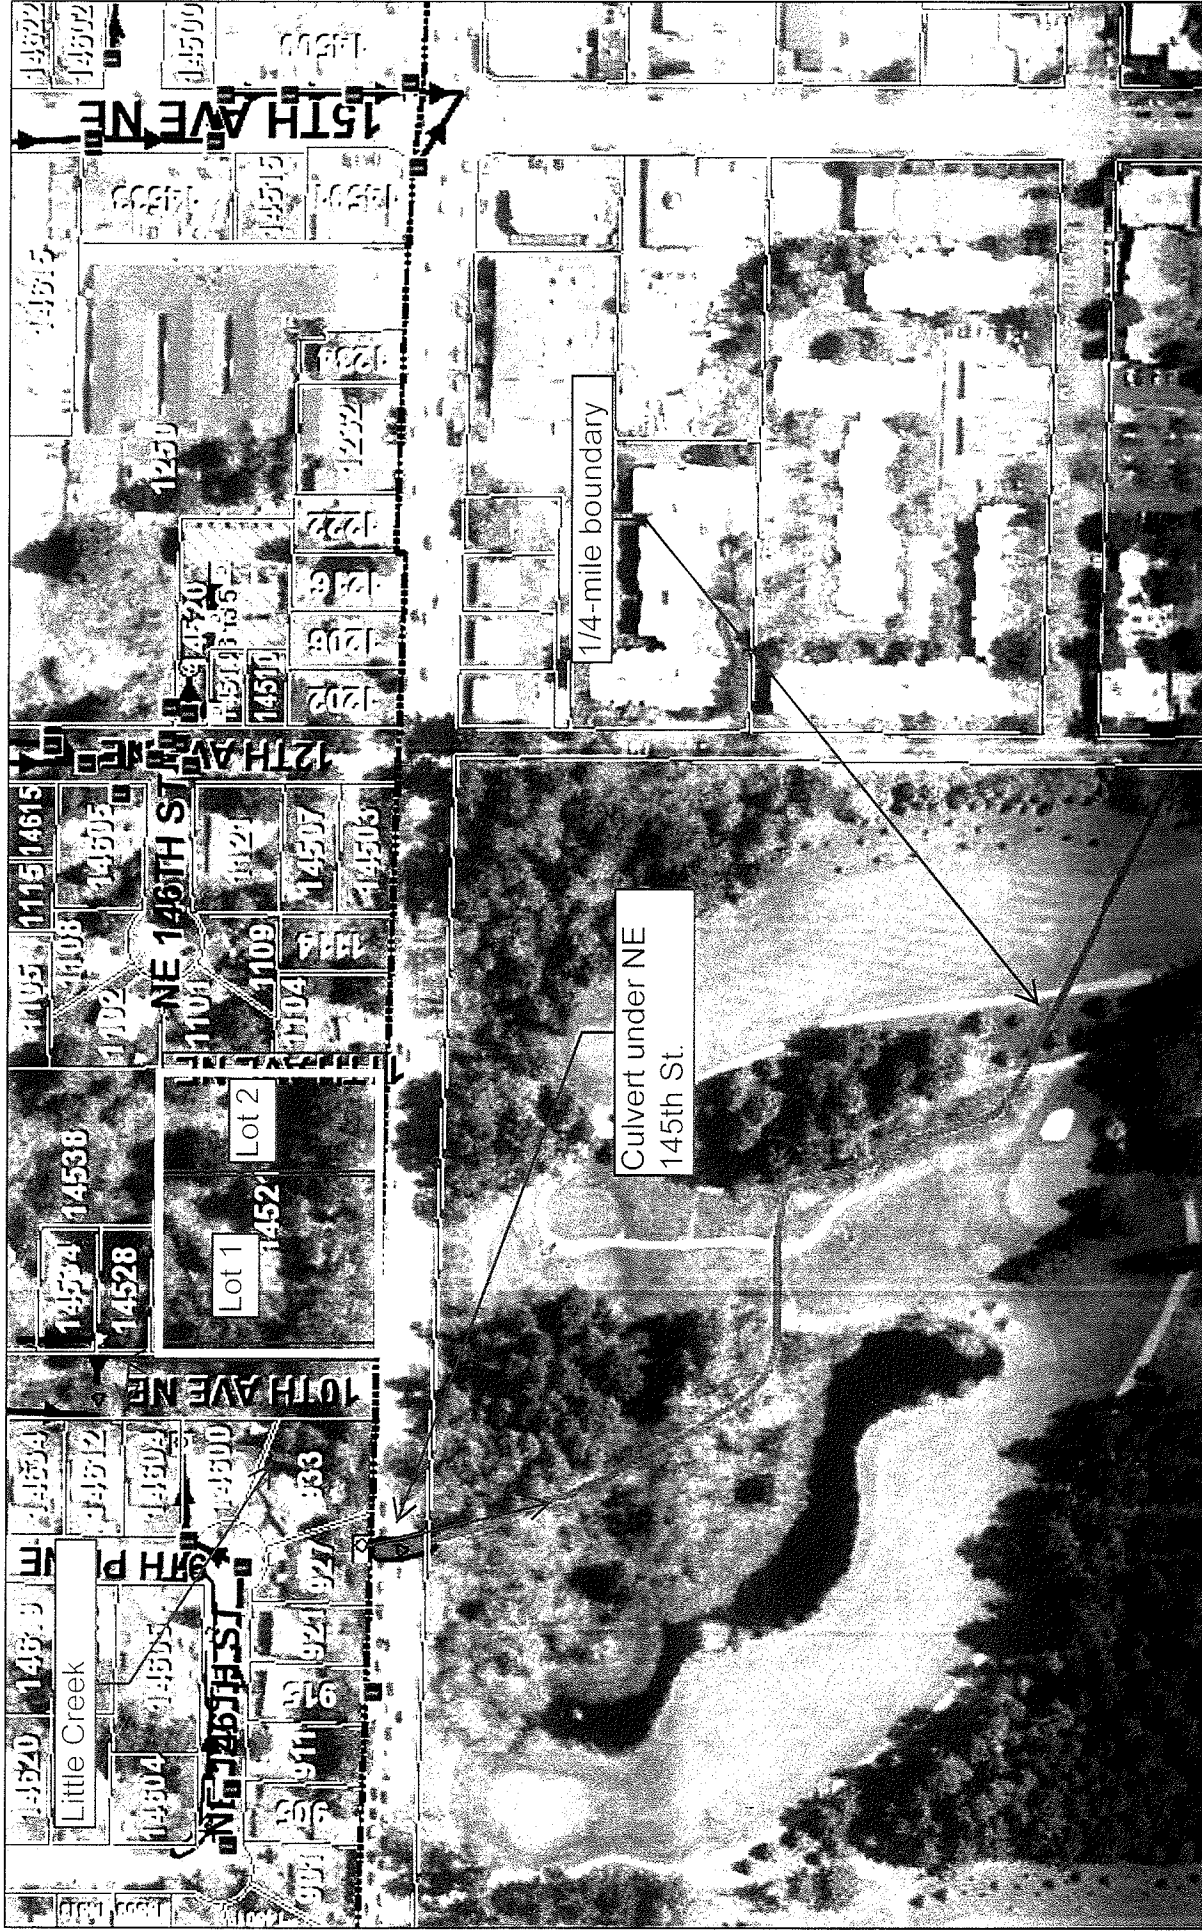
# Surface Water Facilities

Runoff from both Lot 2 and the developable area of Lot 1 flows east and south into the NE 145<sup>th</sup> St. ROW where flows travel as surface flow within curb and gutter to the 10<sup>th</sup> Ave NE ROW, where they spread and cross the gravel/pavement within 10<sup>th</sup> Ave NE and then over vegetated area prior to entering Little Creek. The steep slope areas of Lot 1 also flow west and north over property lines and into 10<sup>th</sup> Ave NE, where they travel north along the drive surface, and cross the 10<sup>th</sup> Ave NE drive surface by sheet or in undefined shallow concentrations until entering Little Creek. Little Creek is a well-defined heavily vegetated stream with a rock/sand bottom and fairly gentle running slopes between the north property line and the culvert intake under NE 145<sup>th</sup> St. The creek was flowing on the day of the investigation. The intake and discharge points for the culvert passing the creek under 145<sup>th</sup> St ROW were obscured by heavy vegetation and blackberries and could not be sized and typed, and construction plans for the culvert are unavailable. Flows continue in a defined creek (Thornton Creek) on the south side of NE 145<sup>th</sup> St. on a Private Golf Course. The creek runs south and east for another 800 ft within the golf course before crossing the ¼-mile threshold. Flows continue south within the golf course.
